FACILITY CONDITION ASSESSMENT

East Central Lower Elementary | November 2020

Jackson CS - East Central Lower Elementary

Executive Summary

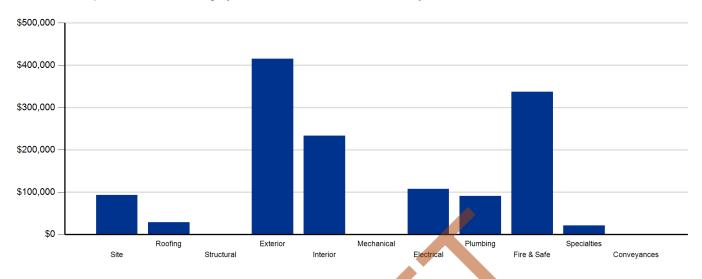
Figure 1: System Deficiencies

The chart below represents the building systems and associated deficiency costs.
